Bringing degraded land to agricultural use

impact of soil and water conservation activities and integrated approach

D. S. Thakur¹, G. K. Sharma² and D. H. Ranade³

Indira Gandhi Krishi Vishwa Vidyalaya, Campus Jagdalpur (Chhattisgarh) 492 012

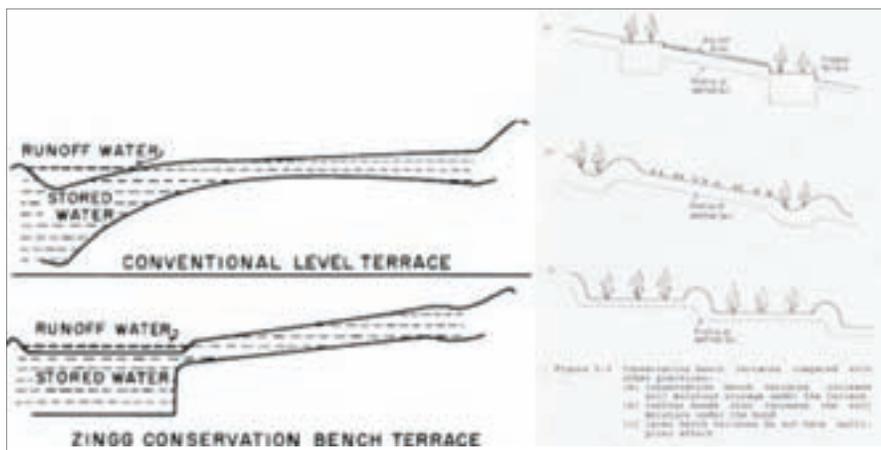
Fig.1. Zing conservation bench terrace

Construction of tanks: Zing's terracing: Three excavated tanks were constructed at the lowest portion where topography becomes little flatter to collect the runoff water so that a concept of Zing's terracing is adopted which is a special type of bench terrace designed for dryland moisture conservation. It typically employs an earthen embankment similar to the ridge terrace; a part of the terrace interval immediately above the ridge is bench-leveled. Runoff water from the sloping area is retained on the leveled/excavated area

and absorbed/retained by the soil. The stored water would be utilized for irrigating the donor areas during the stress period. The stored water in these tanks will also reduce the amount of runoff leaving the fields without aiding to soil moisture profile. Thus, zing terracing is the practice of developing conservation bench terrace which is another type of rainfall multiplier, using part of land as a catchment to provide additional runoff onto level terrace on which crops are grown.

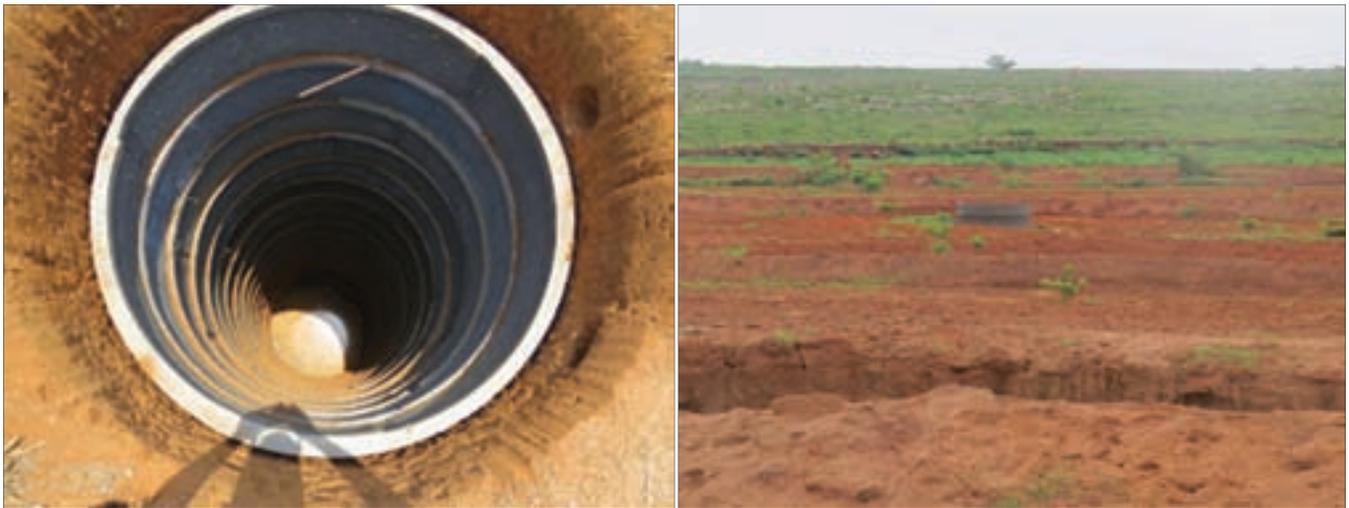
Open well in the terraced field getting recharged at higher rate due to increased runoff retention in the terraced portion and thus allowing more ground water recharge

Construction of various soil and water conservation measures has increased the total soil moisture conservation as evident from the surface storage in the sunken pond, leveled fields, due to diversion bunds and drains and increased ground water recharge. It has been observed that due to increased recharge the open well constructed in this portion are fully recharged and retaining water upto within 1 m from the soil surface which is otherwise not possible in the untreated area. This has increased its utilization by crops leading to satisfactory growth of crops and plants grown on the reclaimed portion.

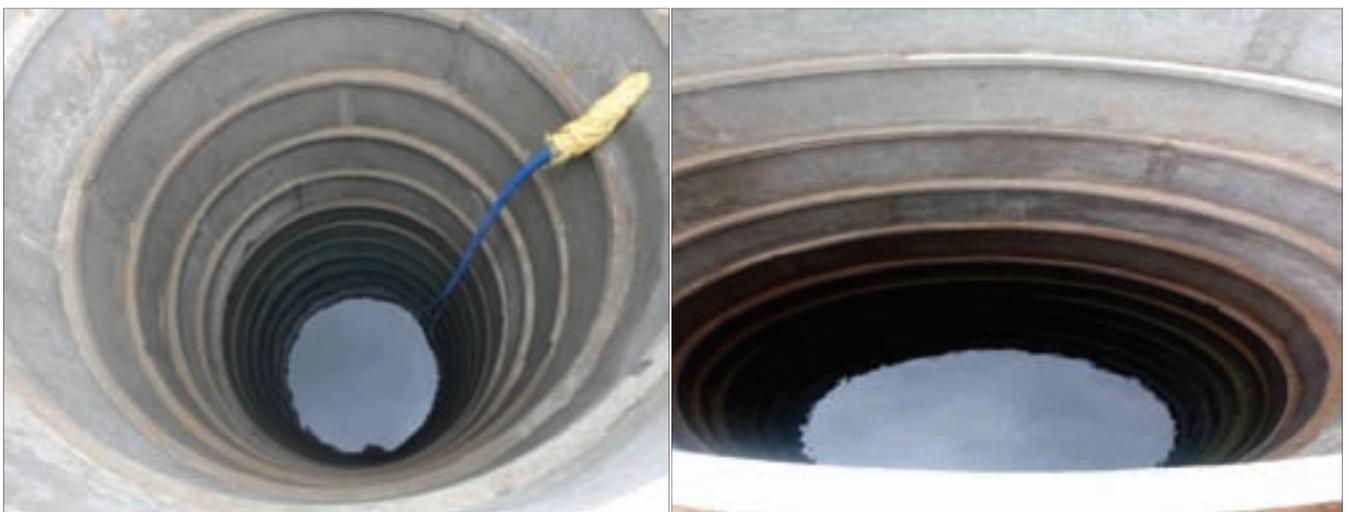
Recharging of the open well at faster rate during rainy season 2014
